ANALYSIS AND DOCUMENTATION OF THE  
“MITHOLZ” UNDERGROUND AMMUNITION STORAGE  
ACCIDENTAL EXPLOSION IN SWITZERLAND

Twenty-Seventh DoD Explosives Safety Seminar  
Department of Defense Explosives Safety Board  
Las Vegas, Nevada

August 20 - 22, 1996

**HANSJÖRG RYTZ and KHOSROW BAKHTAR**

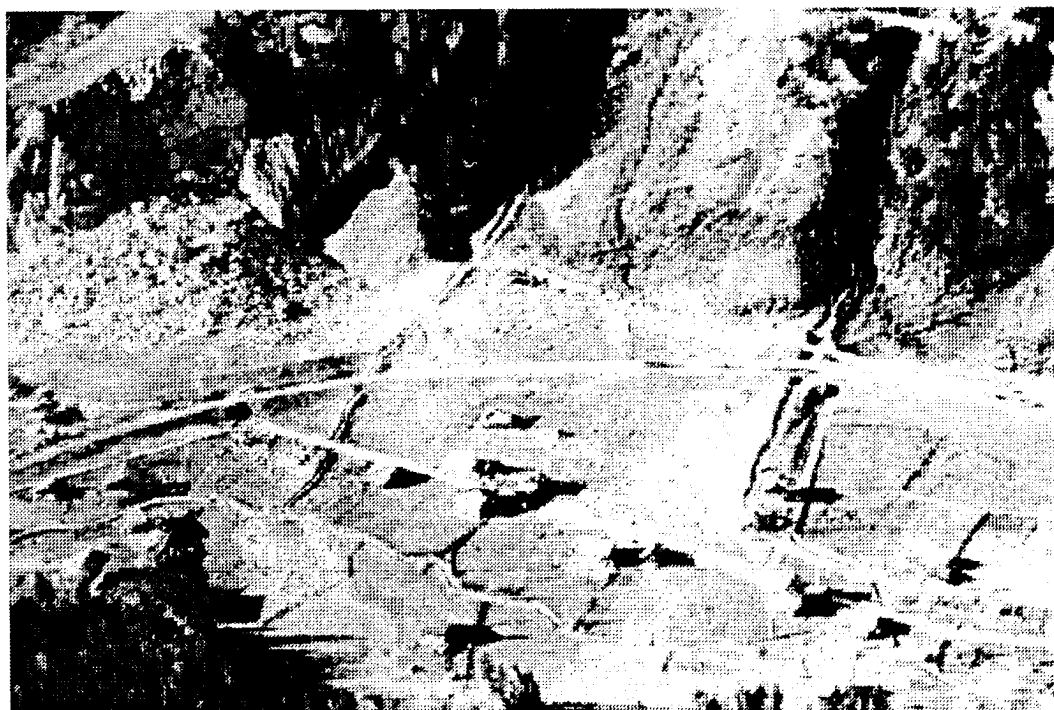
*Ten minutes past midnight the third and most powerful explosion threw out an enormous amount of ammunition, burning explosives and rock debris of various sizes - together with blast flames up to 150 m high. This followed by the collapse of the northern edge of rock wall. Figures 4 to 10 provide details of damage caused by the blast in the area.*

*Figure 4. Photograph Showing Magazine Site Post-Blast.*

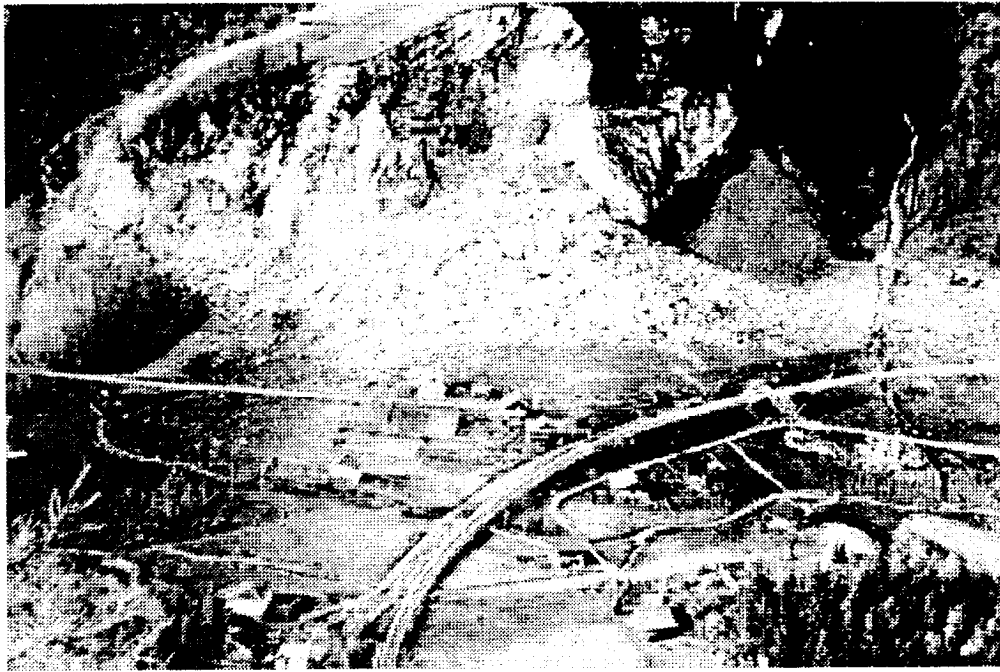
*Figure 5. A Close-Up Photograph of Detonated Magazine.*

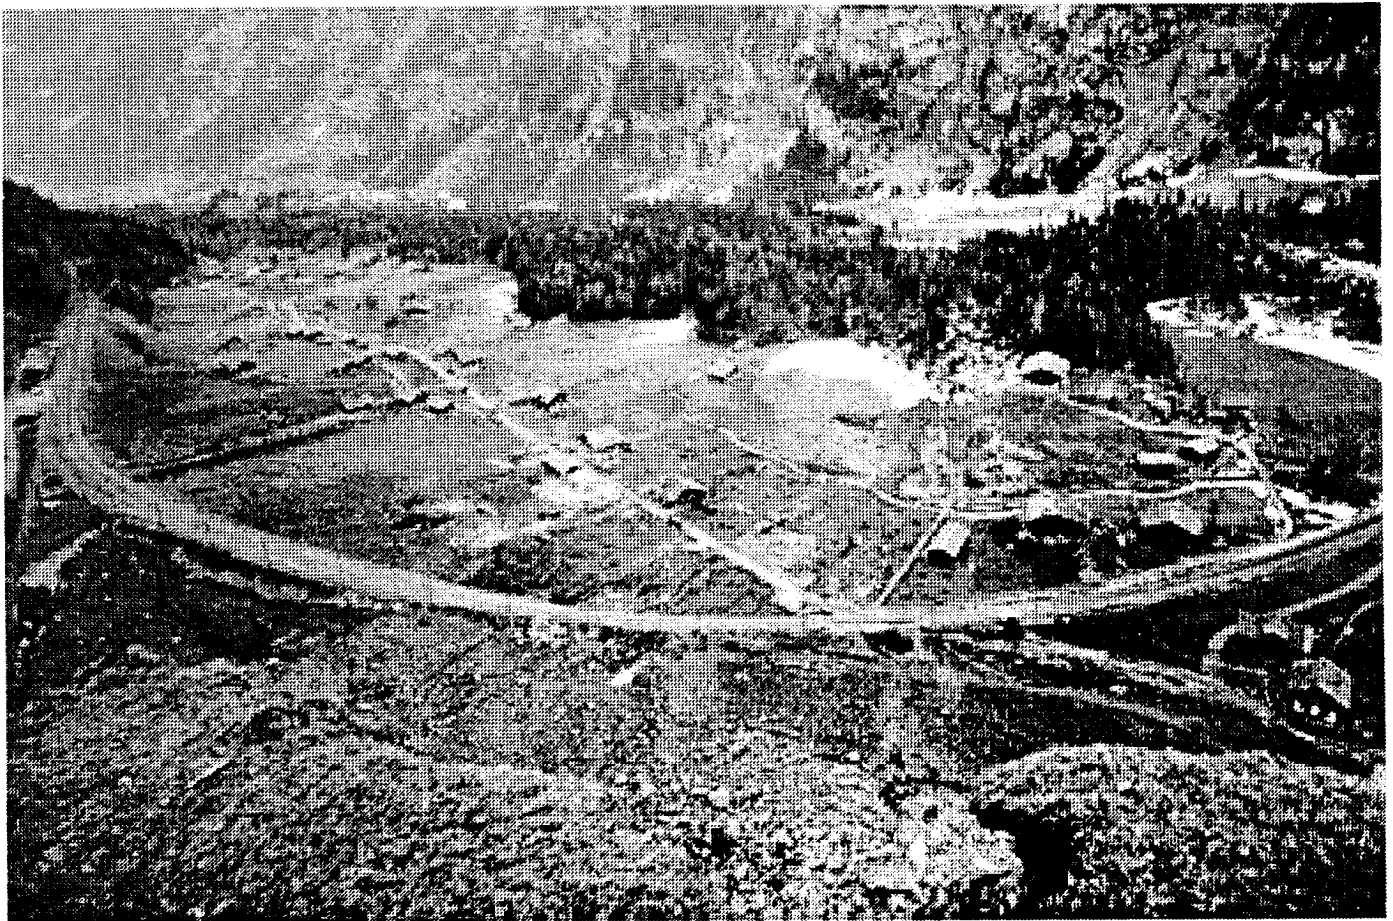
*Figure 6. Overall View of Accident Site.*

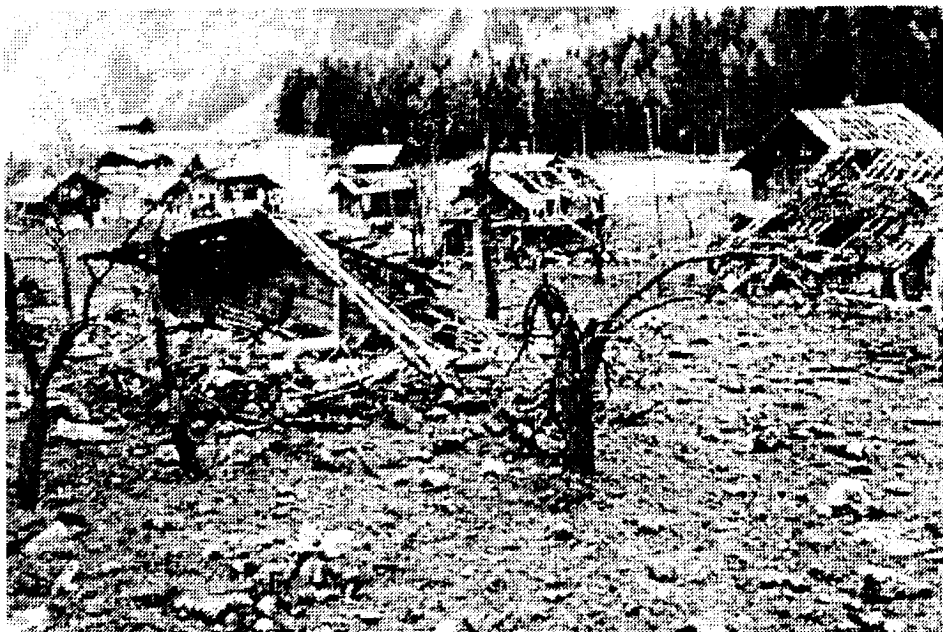
*Figure 8. Observed Damage to Inhabited Buildings.*

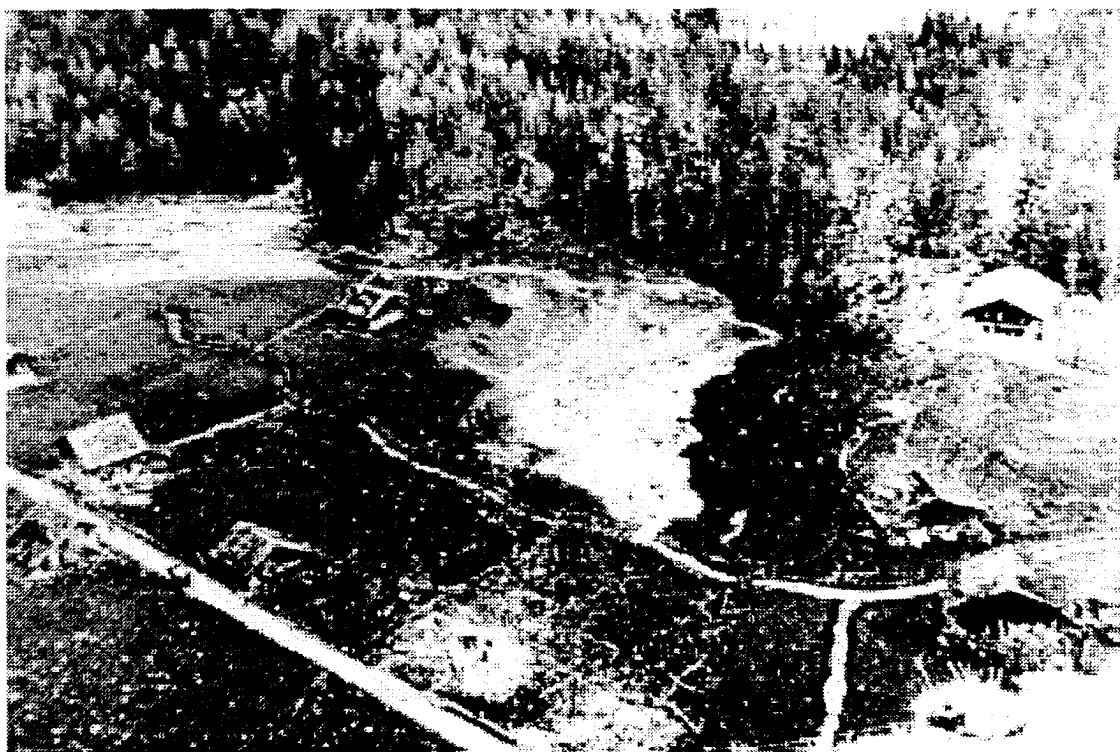
*Figure 9. Photograph Showing Fragment Density Post-Blast.*

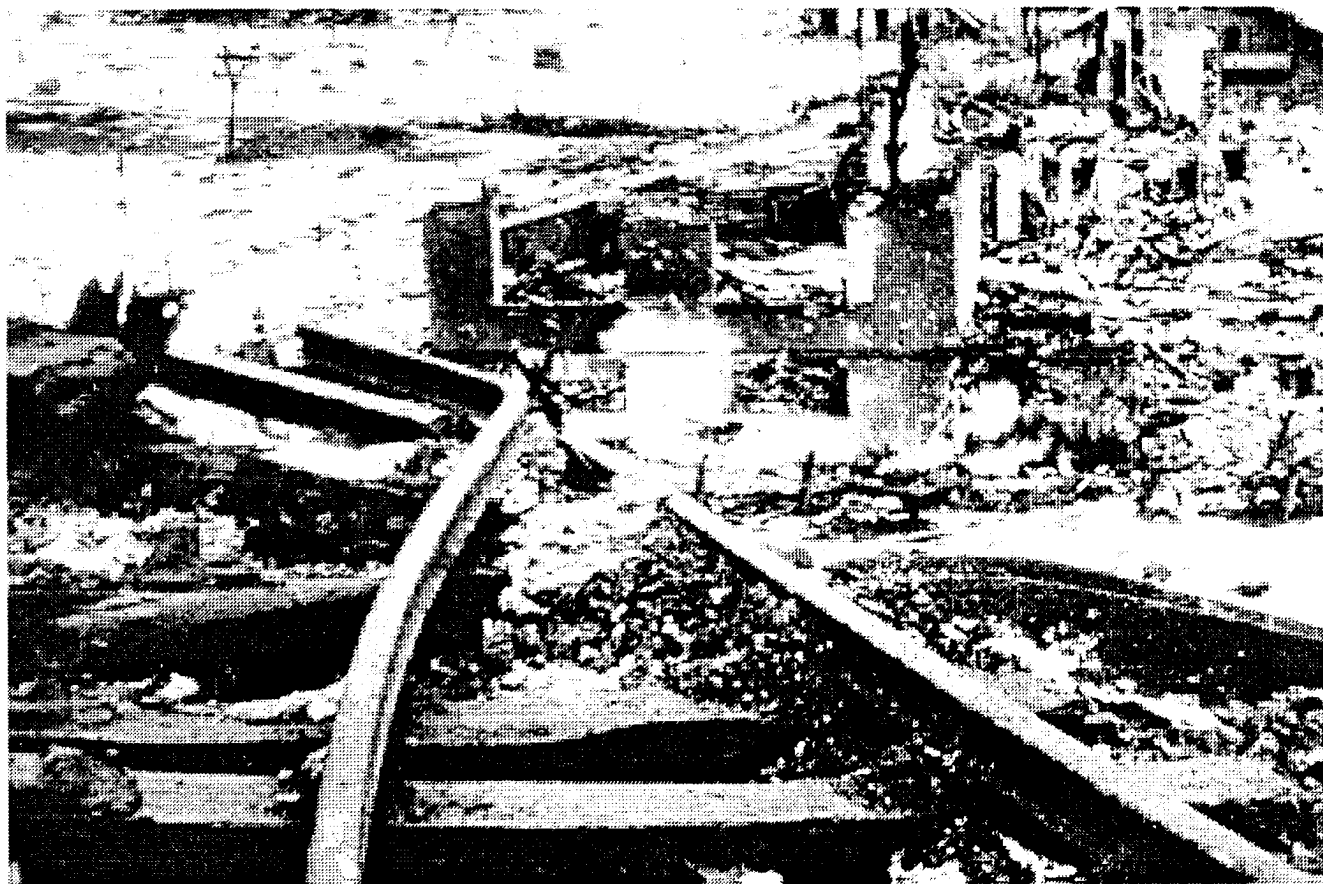
*The first massive explosion occurred at 11:30 pm with flames escaping from all portals and ventilation openings. Blast flames reaching 30 m high set fire to several trees above the 100 meter high rock wall. At 11:35 a second big explosion occurred and was detected by the seismographs 115 km away in the Swiss Earthquake Institute. Several houses and the railway station were destroyed during this explosion as a result of falling rock and thrown ammunition.*

*Figure 10. Photograph Showing Blast-Induced Damage to the Railway Station.*

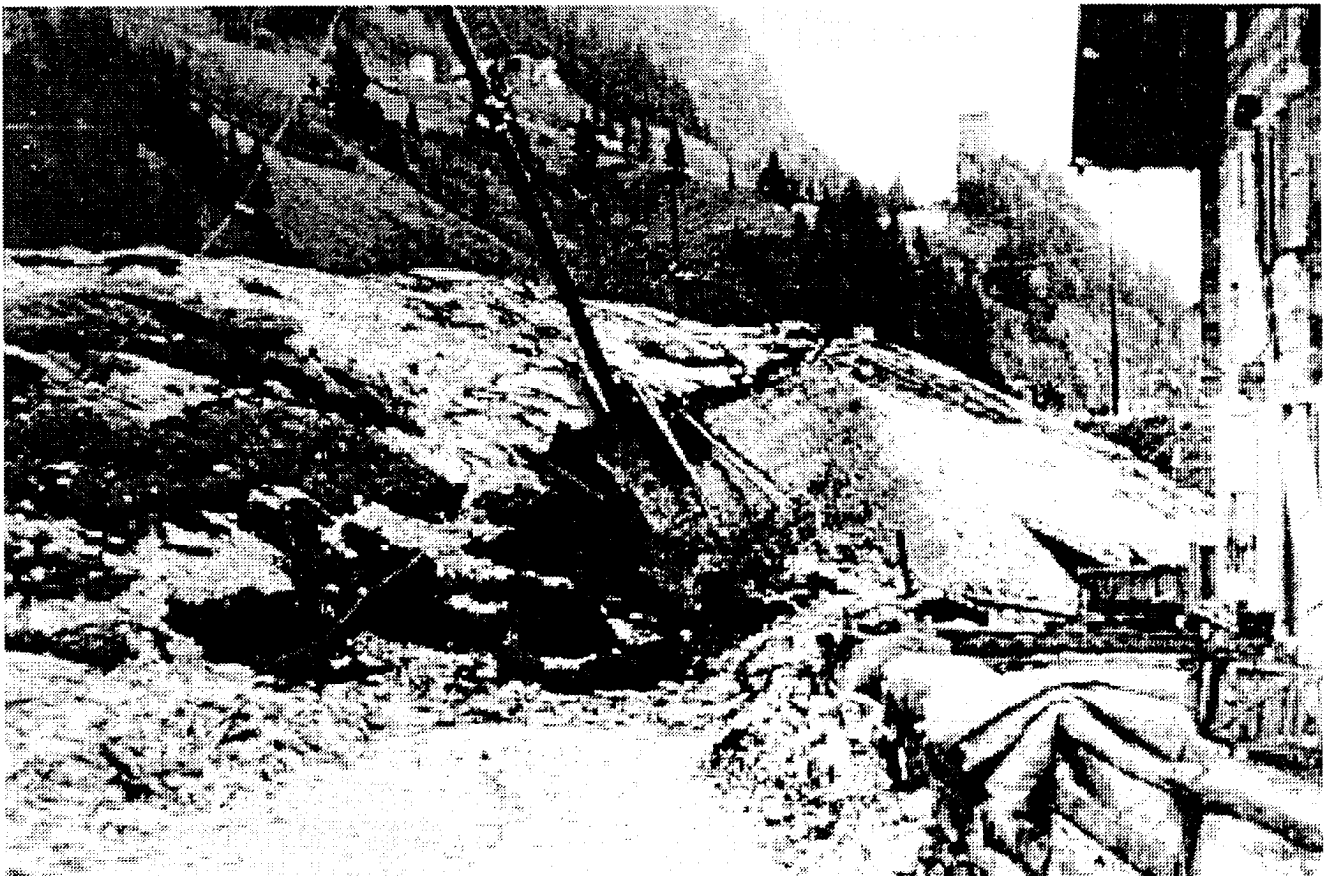
*The collapse of the northern edge of the rock wall (approximate total volume of 240,000 m<sup>3</sup>) displaced the soil in a way that a part of the road was lifted up (Figure 11).*

*Figure 11. Structural Damage Caused to the Near-By Road.*

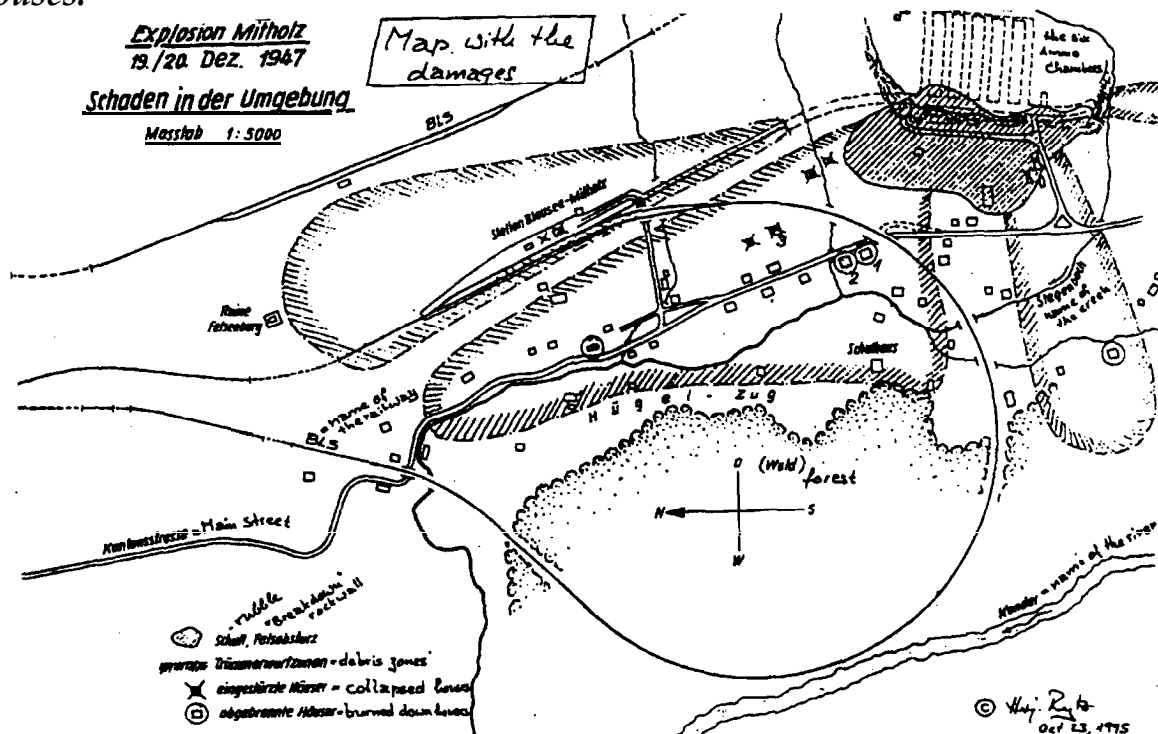
All other damages could be clearly separated into four main damage zones (Figure 12) corresponding to the direction of the blasts away from the railway tunnel and the two portals. The fourth (smallest) zone was built when the back part of the tunnel near rock wall was destroyed.

The North Damage Zone was 660 m long, however, debris were found at a range of 1300 — 1800 m. This is similar to the gas tube or shock tube effects.

The Northwest Damage Zone was only 350 m long because a hill acted as a barricade to contain the blast. The damage in this zone appeared to be more extensive and destroyed three houses.

Figure 12. Topographic Map Used to Describe Various Damage Zones.

The Southwest Damage Zone was 450 m long causing the collapse of two office and one inhabited house buildings. A lot of thrown out pieces, items and debris were covered by falling parts of the rock wall.

The South Damage Zone was 100 m long and showed much less debris density and destruction.
